Concrete Layer Assistance & Survey

POSIBLOC™

CLAS did a complete evaluation of the POSIBLOC™ in August 2017

A CLAS inspector remained a full month at the ALFAW site in IRAK where three POSIBLOC™ were to be implemented. We have seen an improvement in the system compared to what we saw on the RAS LAFFAN, KHALIFA and BARAKAH projects where the POSIBLOC™ system was abandoned by the contractors.

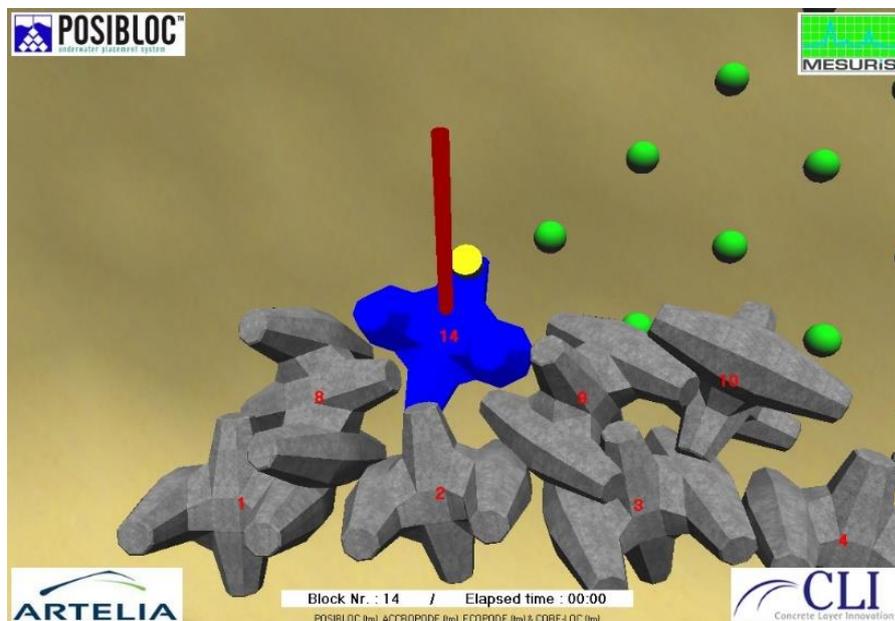
The POSIBLOC™ principle is based on measurement. It works with a VISIBLOC™ virtual 3D visualization software which allows to visualize in real time the information supplied by the measuring equipment.

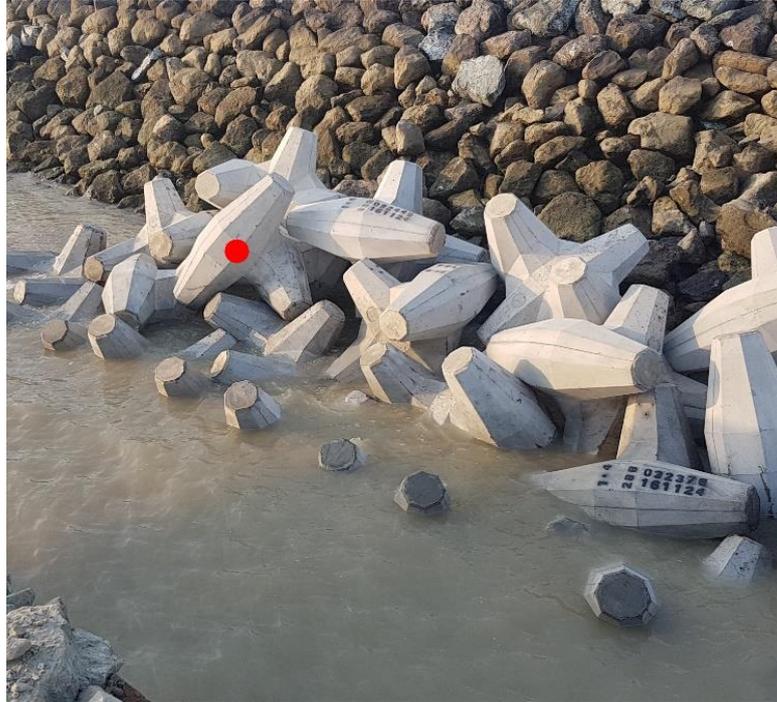
The software also did not allow to identify the blocks out of profiles. It had a lot of blocks out of profiles that were not.

One CORELOC™ out of profile

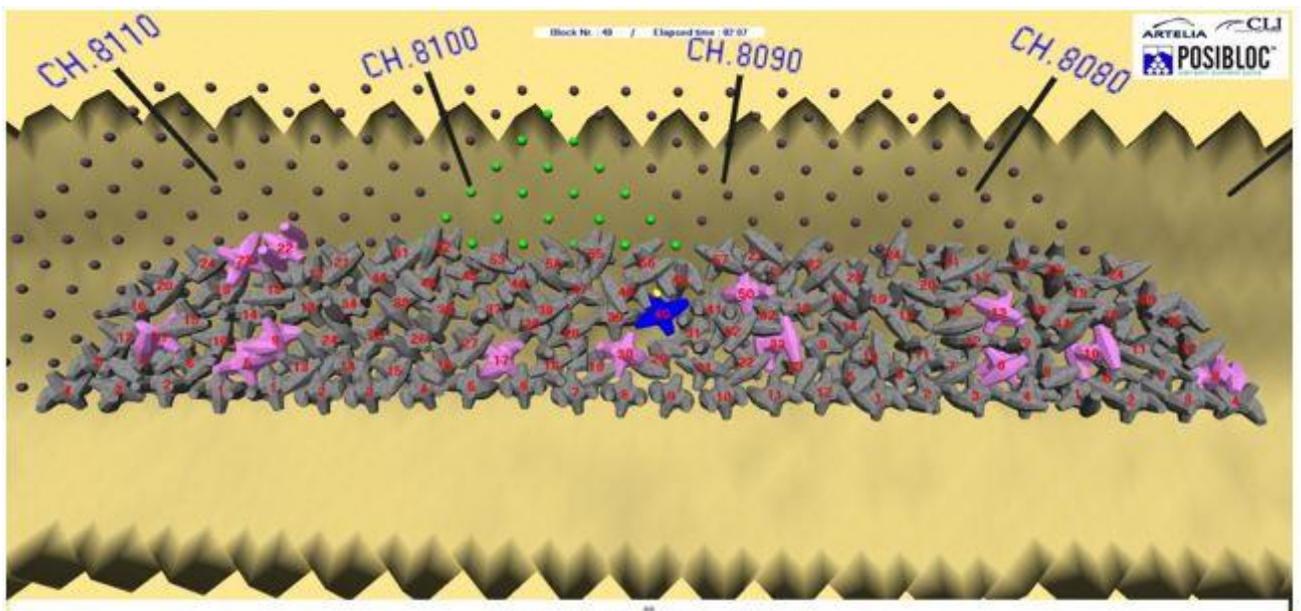
The blocks colored in pink are indicated as out of profile by the software VISIBLOC PROCESSING but only one of them was really out of profile.

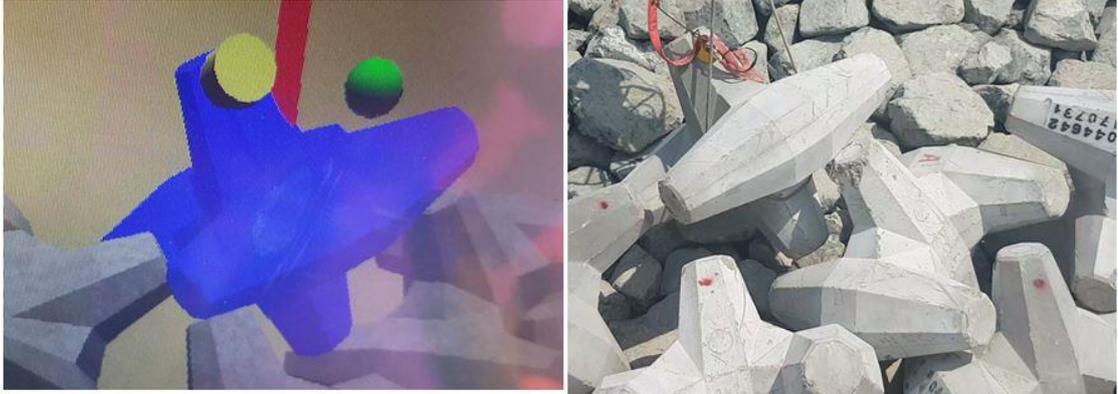
The interlocking of the blocks could not be appreciated properly because the software shows interlocking defects that do not exist or doesn't show existing bad interlocking.

CORELOC™ well placed on the screen but not well placed in reality (pictures made at the same time)

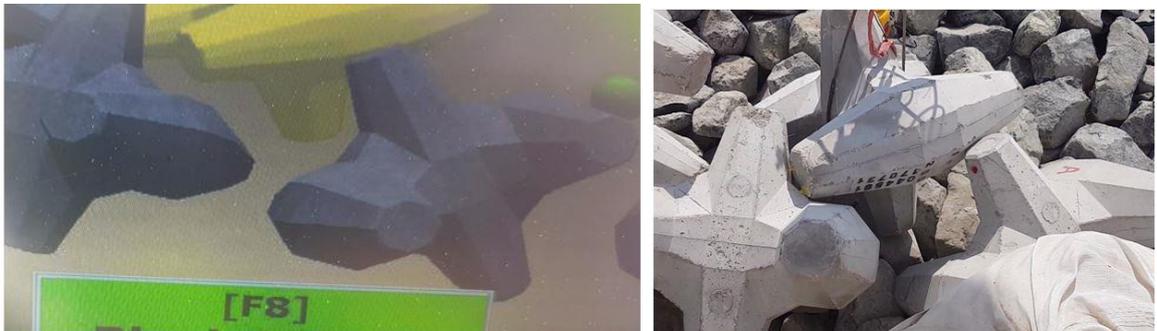
The same CORELOC™ not well interlocked on the screen but well interlocked in the reality (pictures made at the same time)

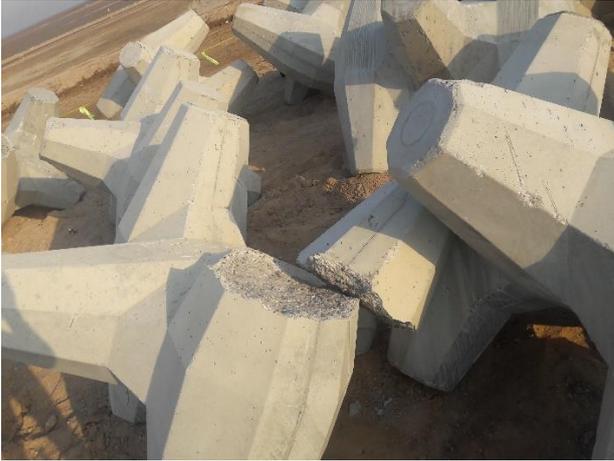
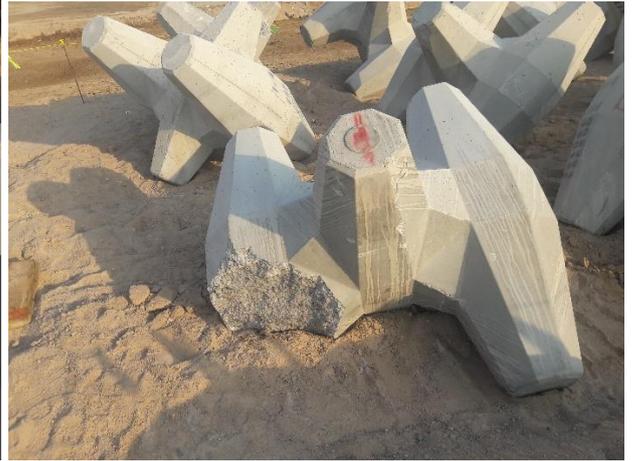
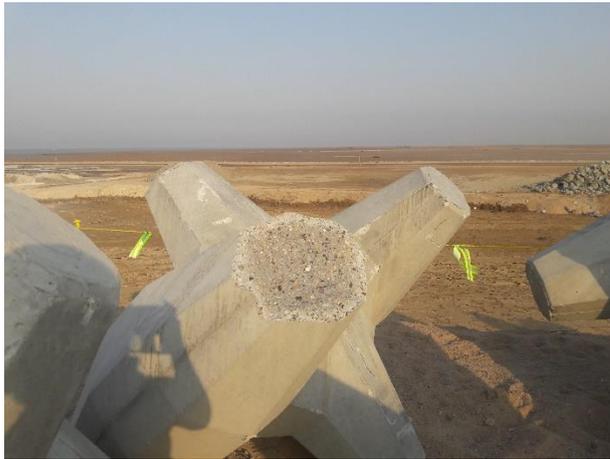
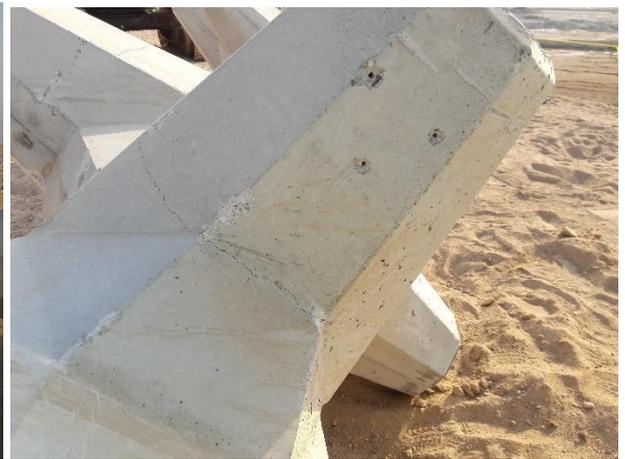
The POSIBLOC™ system and its software did not identify the broken blocks. The weight sensor is intended to adjust the cable tension at the time of data recording. It is not designed to appreciate the weight in the water knowing that the limit of rupture accepted by CLI is 2% for the CORELOC™.

When the software shown that the CORELOC™ was not in contact with the row below, the operator tried to adjust it properly, in order to avoid settlements. But due to the wrong information given by the software, the consequence was some CORELOC™ broken during the placement.

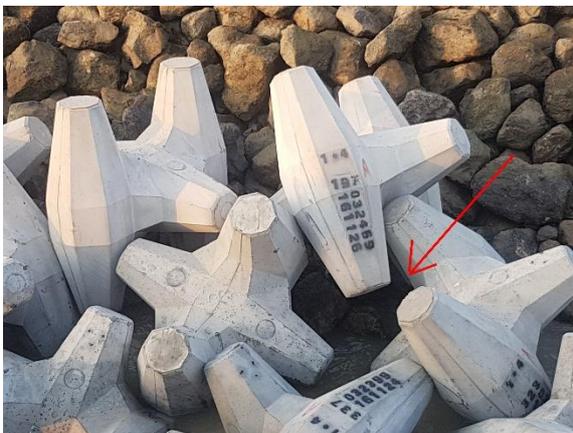
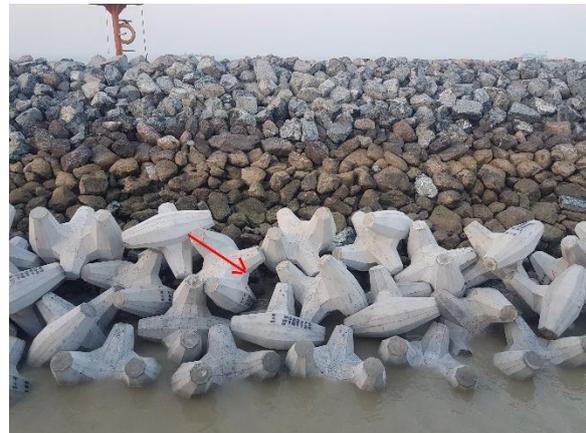
The existing holes were not shown on the VISIBLOC™ software. The software indicates holes that do not exist.

Existing gaps not identified on the software

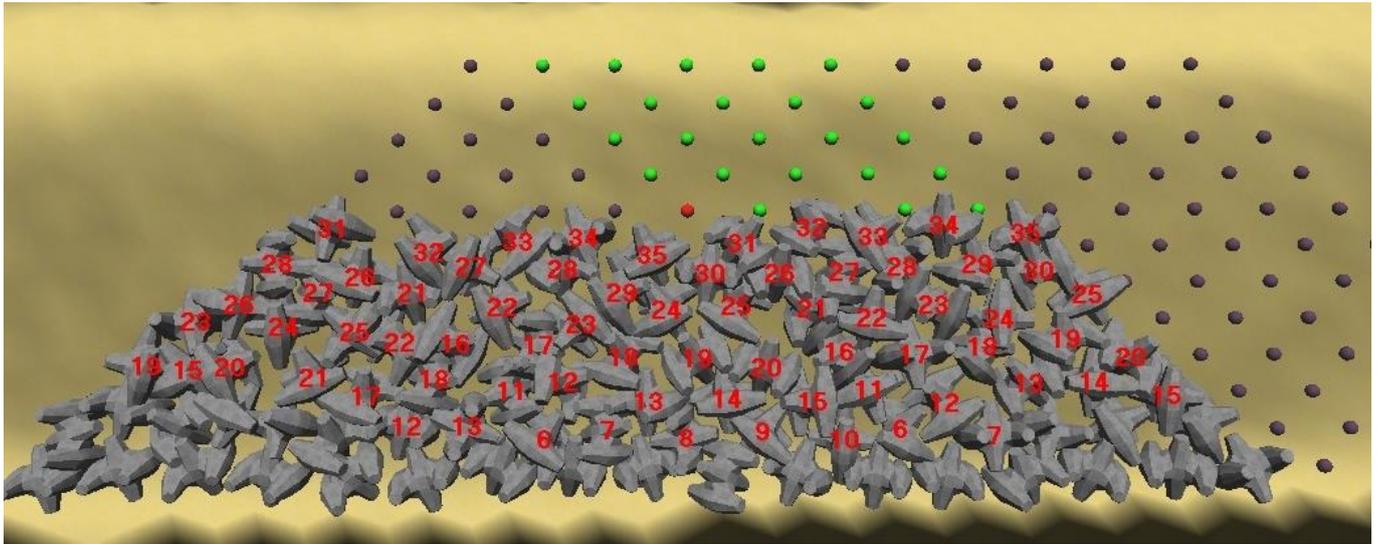
On the software we can see a lot of gaps, but not the real ones

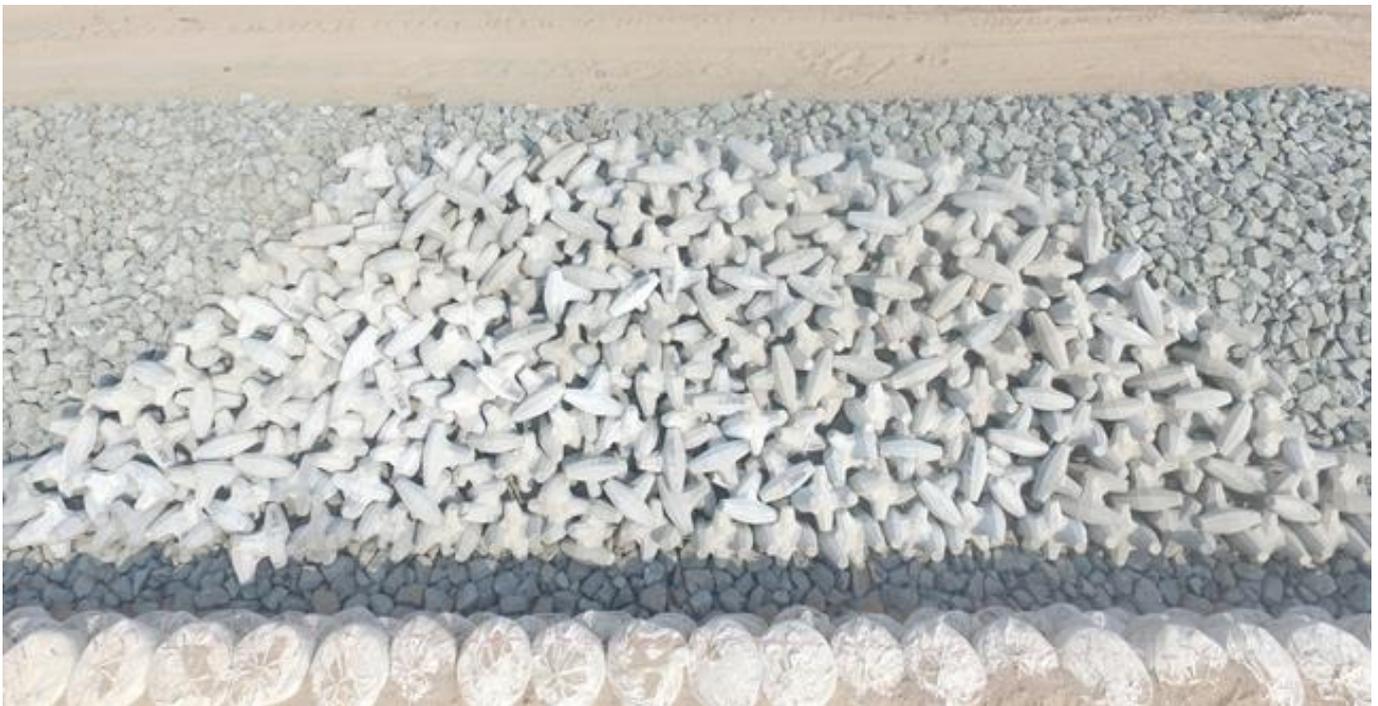
No gaps in the reality

We recommend to not use the POSIBLOC™ system to approve the placement of the ACCROPODE™, ACCROPODE™II, ECOPODE™, CORELOC™ or X-bloc® blocks.
